Full-Scale Transport Controlled Impact Demonstration

Proceedings of a workshop held at
NASA Langley Research Center
Hampton, Virginia
April 22, 1986

Robert J. Hayduk, *Compiler*
Langley Research Center

Proceedings of a workshop sponsored by
NASA Langley Research Center, Hampton,
Virginia, and the FAA Technical Center,
Atlantic City, New Jersey, and held in
Hampton, Virginia
April 10, 1985

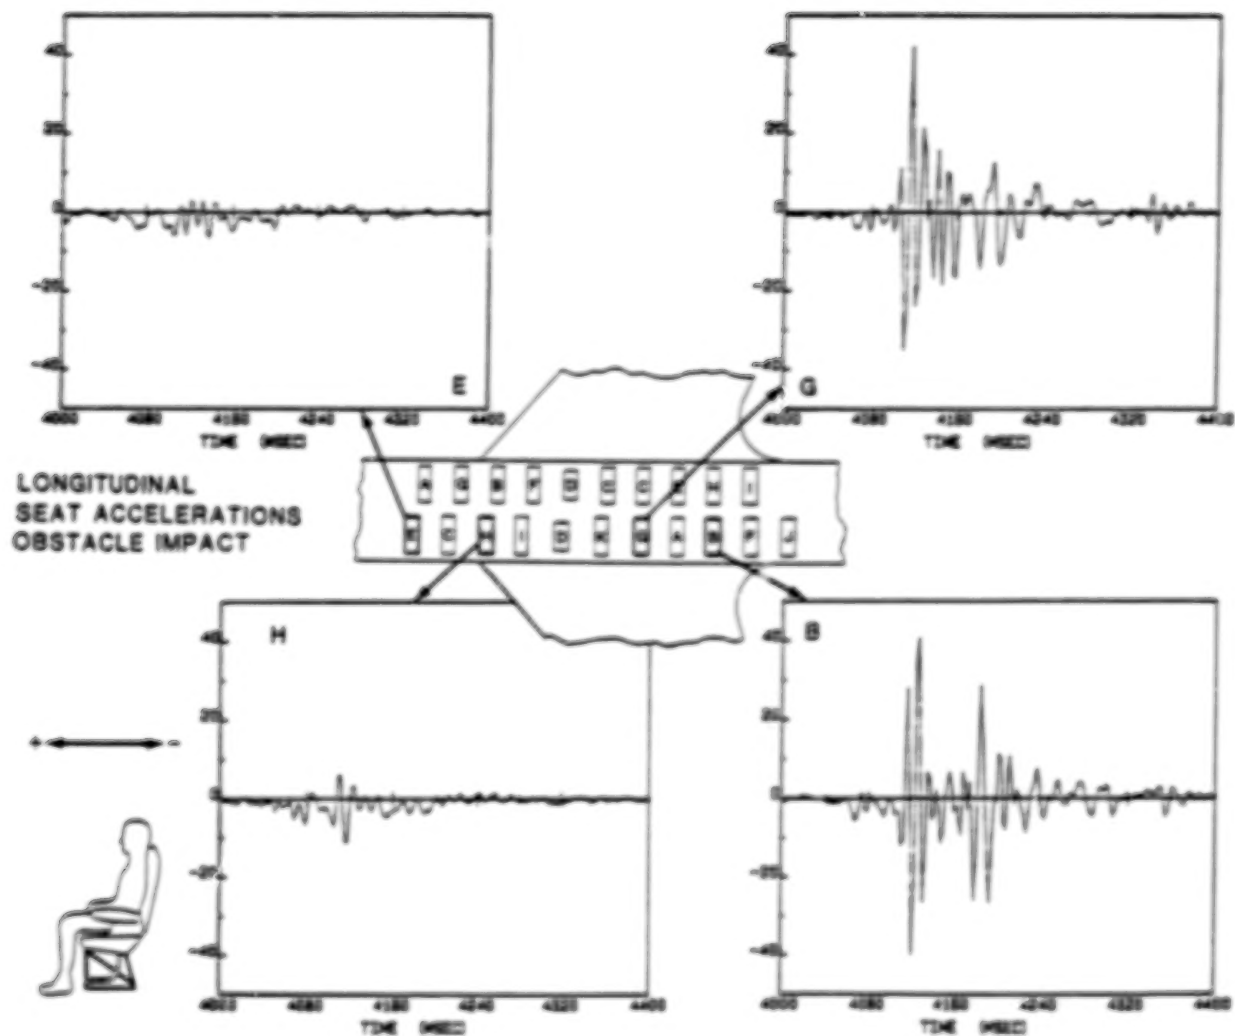
Figure 19.

Figure 19 shows the longitudinal data during obstacle impact for the same four seats. Again, the response is shown to be most severe in the aft portion of the aircraft.

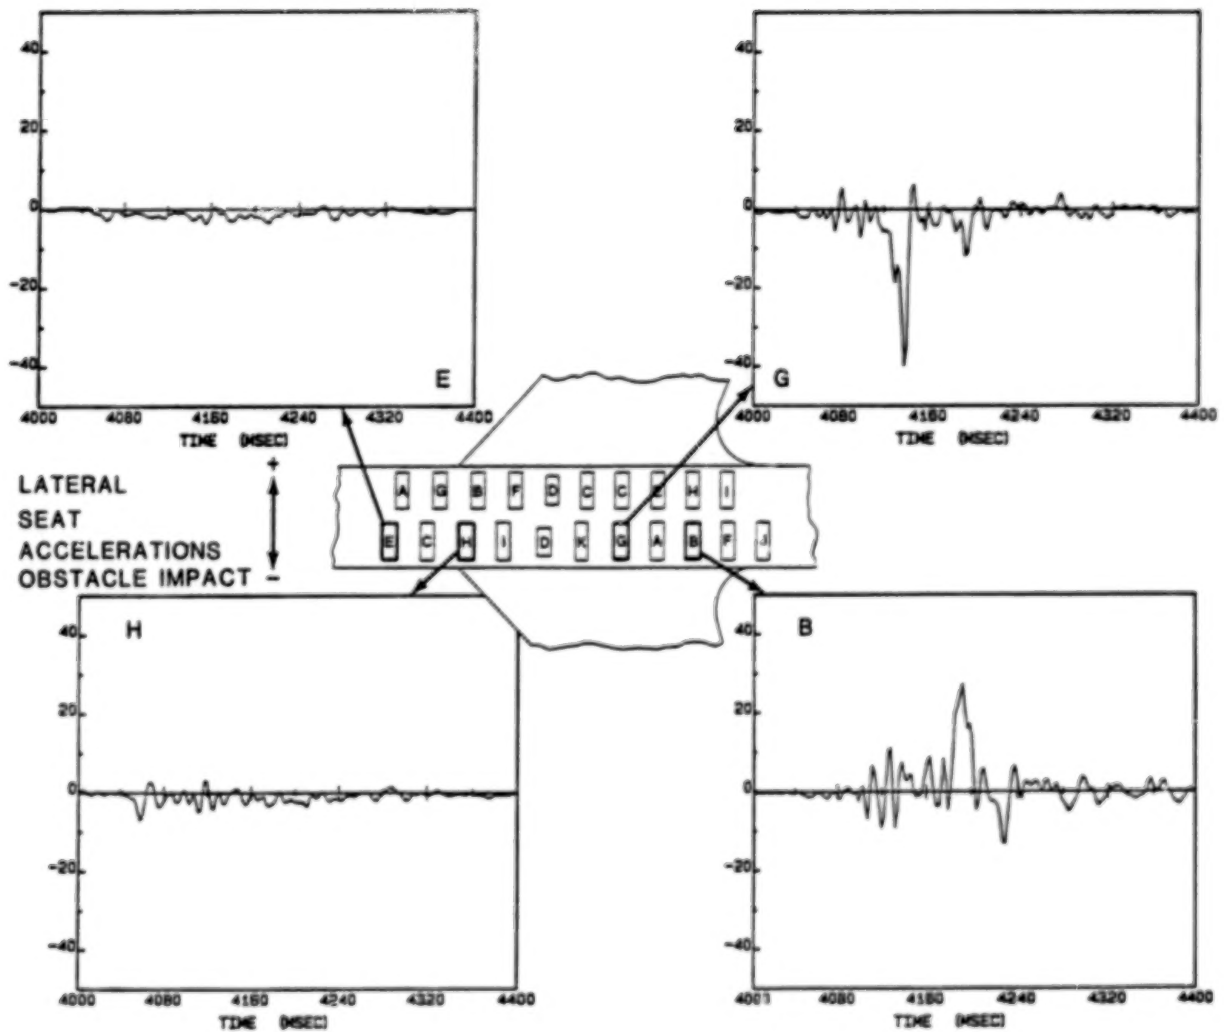
Figure 20.

Figure 20 shows the lateral acceleration component. Note that the main pulses are wider. This is probably consistent with the cutter tearing through the aircraft as it slid sideways.

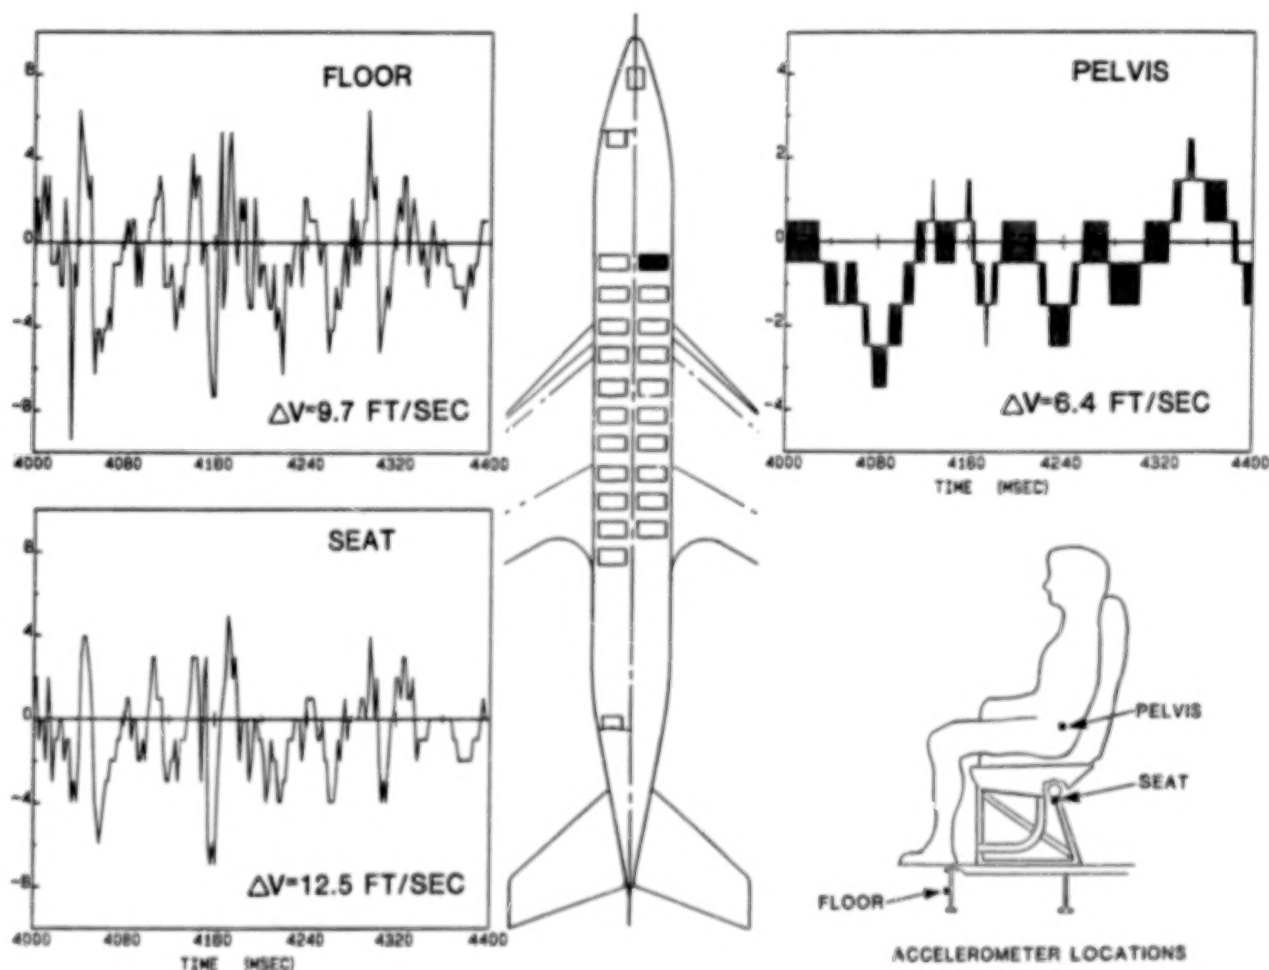
Figure 21.

The next three figures (figures 21-23) show seat and dummy response during obstacle impact. Figure 21 shows comparisons of the floor, seat, and pelvis response for Seat A. This was the most forward seat in the cabin, and similar data for this seat during ground impact has already been shown. Again, the data is consistent. The fact that the floor and seat pan accelerations matched fairly well gives confidence that the transducers were performing properly. This is particularly true of the vertical acceleration. The dummy response is quite different, as would be expected. However, the velocity change for the dummy is also quite different, and this is not so encouraging.

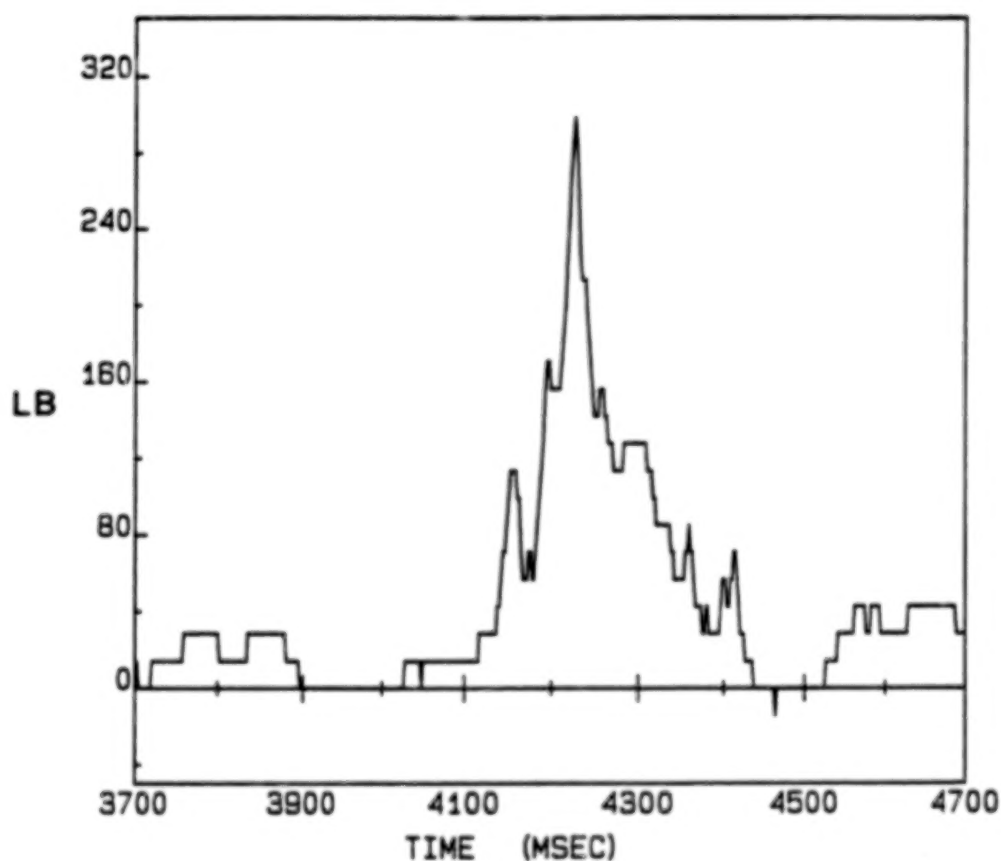
Figure 24.

Figure 24 shows a typical lap belt tensile load, with about a 300-lb peak. This is a low load for a lap belt, and most of the lap belt data reviewed is similar. It is relatively consistent with the measured G loads and the film data which shows that the dummies did not jackknife.

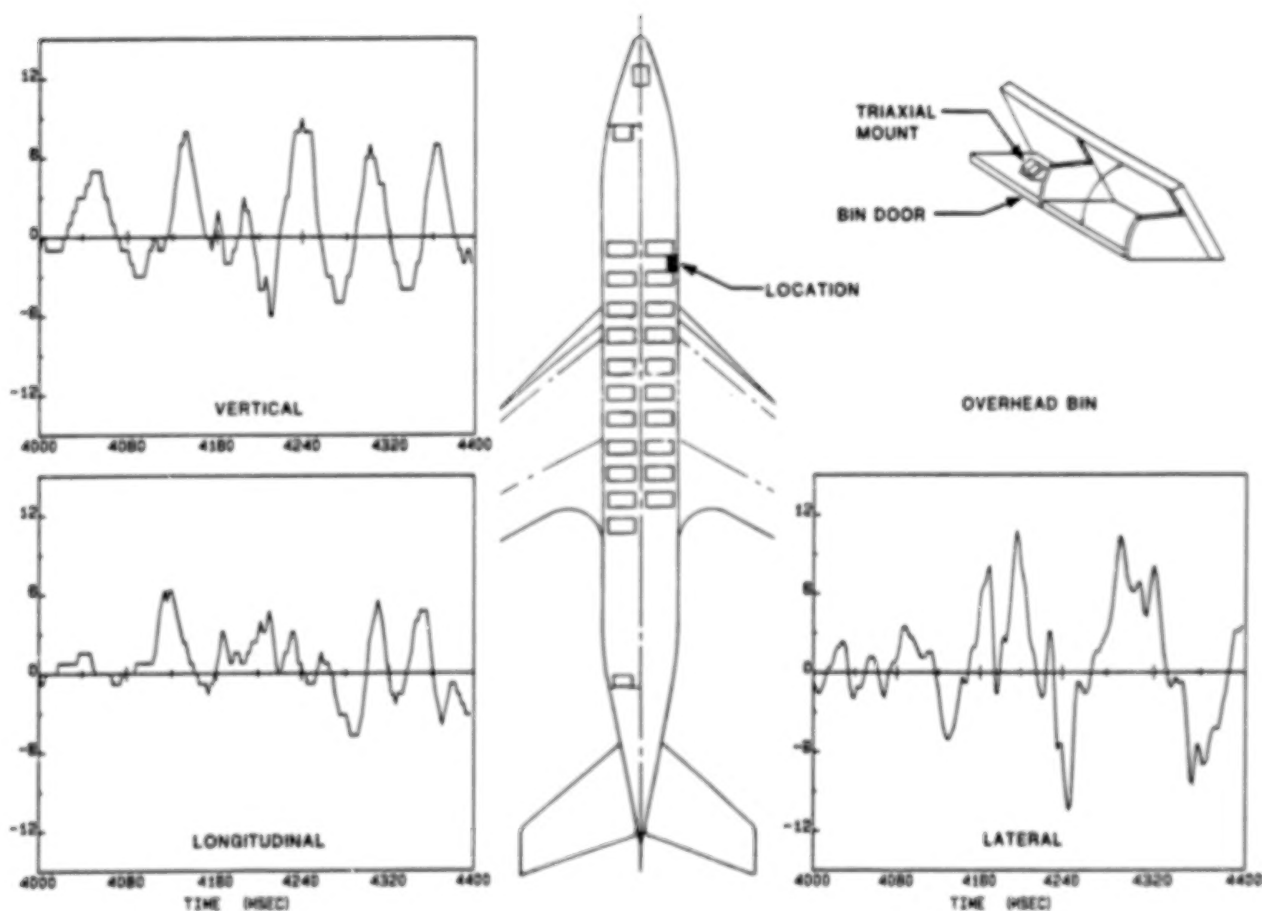
Figure 25.

Figure 25 shows overhead bin data. The FAA had a few accelerometers on an overhead bin that was placed in the aircraft. There was a mass attached to the door of the bin and the accelerometer was mounted to its back. There are peaks of 6 G or more in the vertical and longitudinal directions. Higher values are seen in the lateral direction. This data is from the time of obstacle impact.

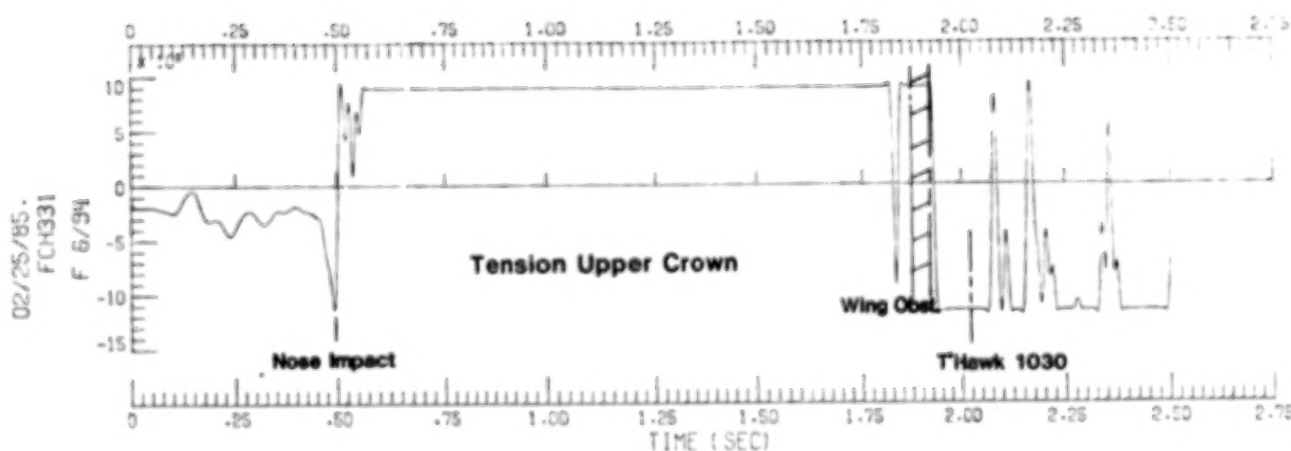
Fuselage B.S. 410 Vertical Bending

The analysis of the moment bridge is incomplete at this time and all these comments represent nothing more than a cursory analysis. B.S. 410 is the forward fuselage bridge and it was located close to the point of impact. The range on the moment bridges was initially proposed to be somewhere between 2 times to about 2-1/4 times limit load. It was felt that the bridges would behave linearly beyond limit load based on some static testing of fuselage shells. Those tests show compressive instability failures of the fuselage shell and linear behavior up to ultimate load levels. Based on the instrumentation listing, the bending bridge ranges were limited to a little less than limit load. That restricted range didn't make too much of a difference, except in a few isolated cases.

This trace illustrates the aircraft impact, obstruction encounter, and the aircraft's response to those events. Analysis of this time history can find:

- Wing Impact
- Nose Impact
- Wing Obstruction Encounter
- Fuselage Impact with the Tomahawk

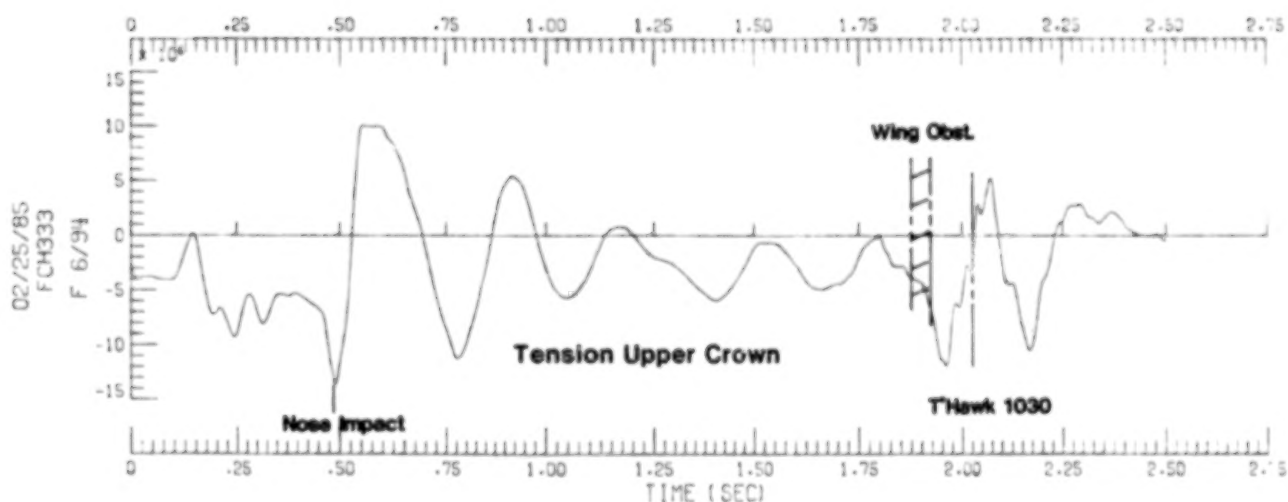
Fuselage B.S. 510 Vertical Bending

The zero moment reference line has yet to be determined; however, it appears as if the airframe is oscillating about the 1 g static load condition.

A little flat spot was noted on one of the peaks where the moment bridge range was slightly exceeded.

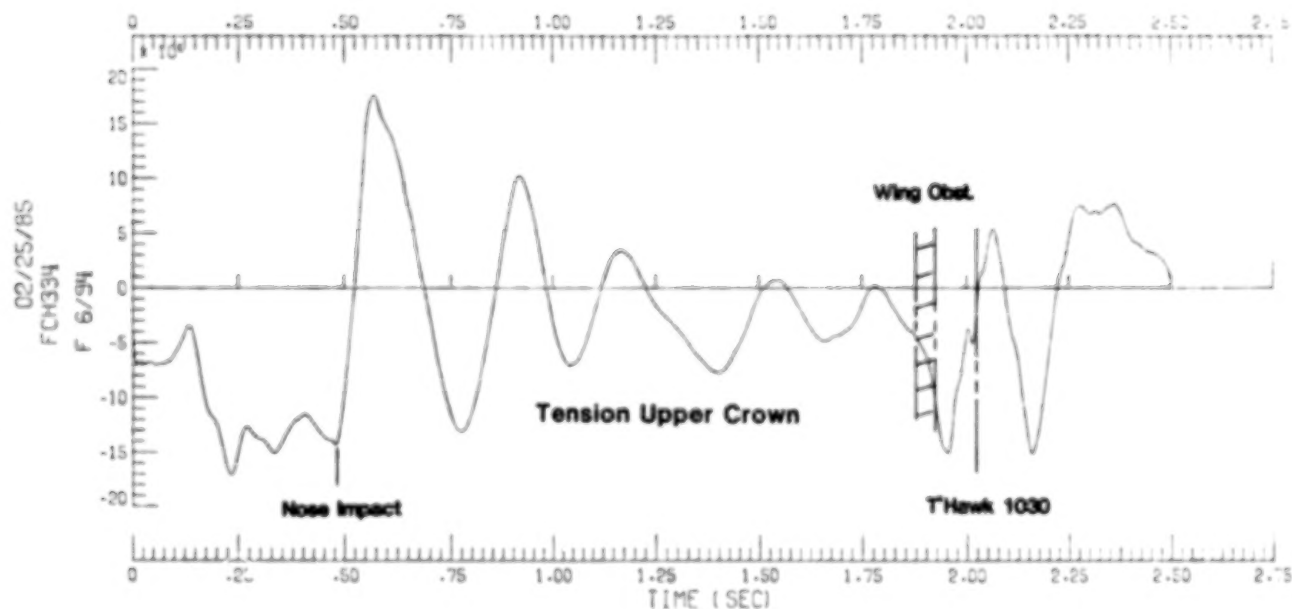
Fuselage B.S. 600J-10 Vertical Bending (Floor)

The 600J-10 time history looks essentially identical to the B.S. 510 time history. One can see the same type of response and the same time reference for the events which took place. Looking at some of the peak moment values, estimating a zero moment reference and using some ratios, one can determine airframe accelerations that seem to match measured accelerometer data. Integrating the acceleration estimates in a simplistic way results in finding velocity change estimates at B.S. 600J-10 and at Station 510 that seem to match the measured data. It appears as if the moment bridges could be used to estimate the initial impact conditions. One can see a consistency here between B.S. 510 and B.S. 600J-10. A consistency of the wave shape, frequency damping and response is noted. It appears as if the bending moment bridges performed well.

The B.S. 600J-10 peak moments exceeded those at B.S. 510 as expected.

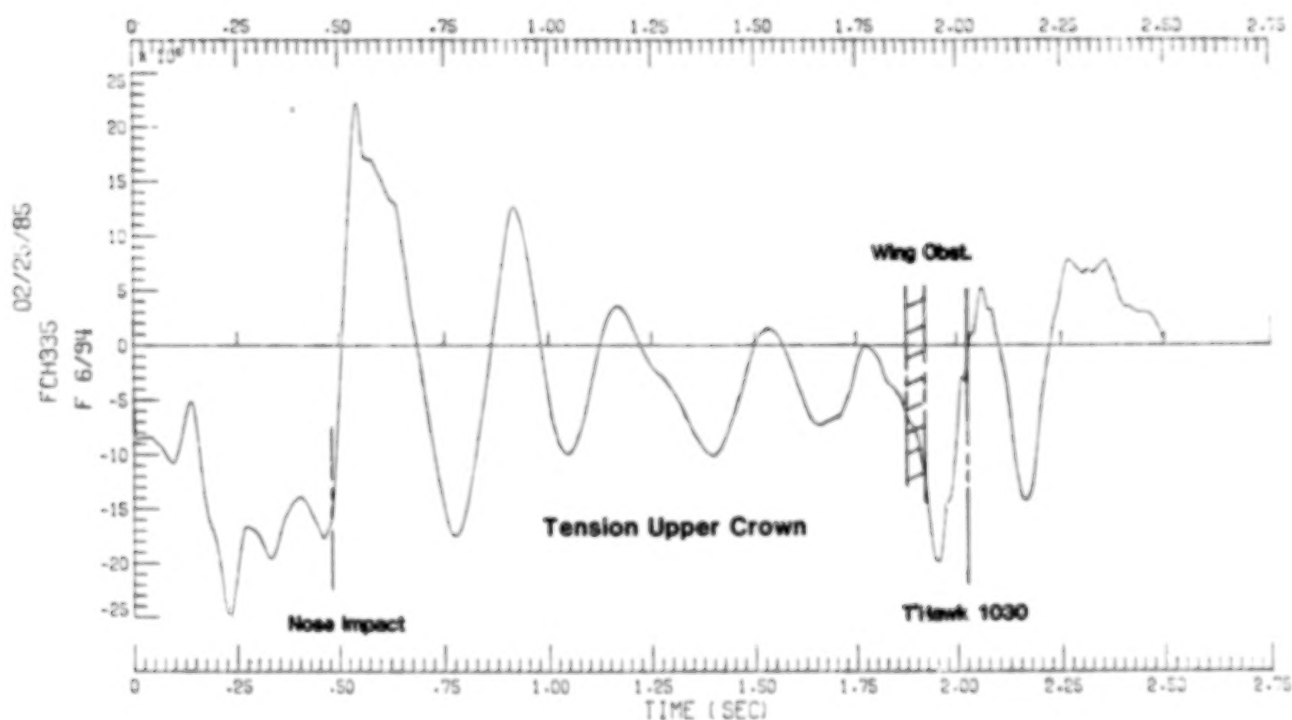
Fuselage B.S. 600J-10 Vertical Bending (Lower)

The 600J-10 lower bridge response looks just like the responses of the other bridges located in the forward fuselage. The 600J-10 (Floor) and 600J-10 (Lower) moment bridges possess the same response, shapes and magnitudes. There is consistency of readings between the bridges. This consistency of response also reflects on the technicians that installed these bridges. They did an excellent job and deserve a lot of credit for the placement and wiring of these bridges.

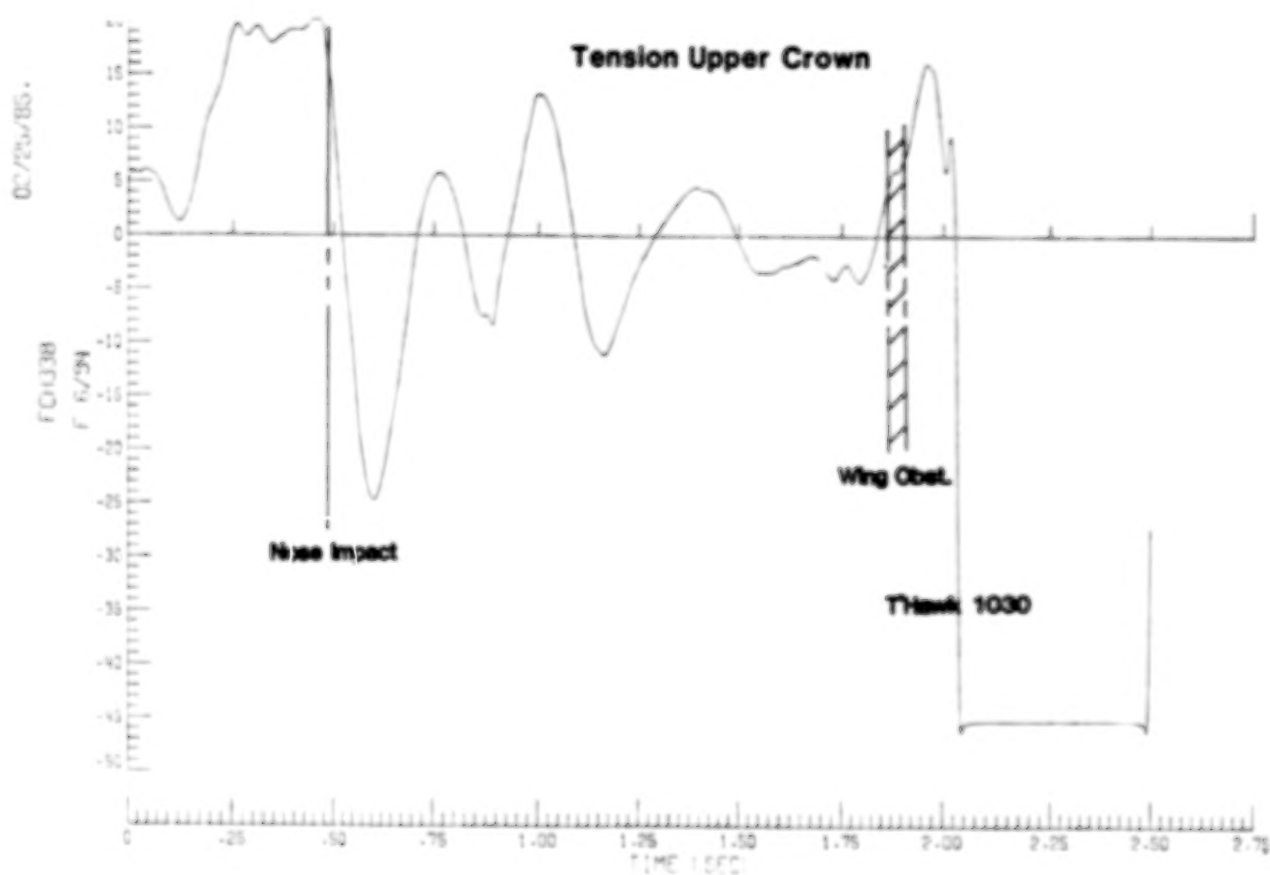
Fuselage B.S. 1030 Vertical Bending (Lower)

The B.S. 1030 (Lower) bridge response is essentially identical to that at B.S. 1030 (Floor). There again exists a consistency of data.

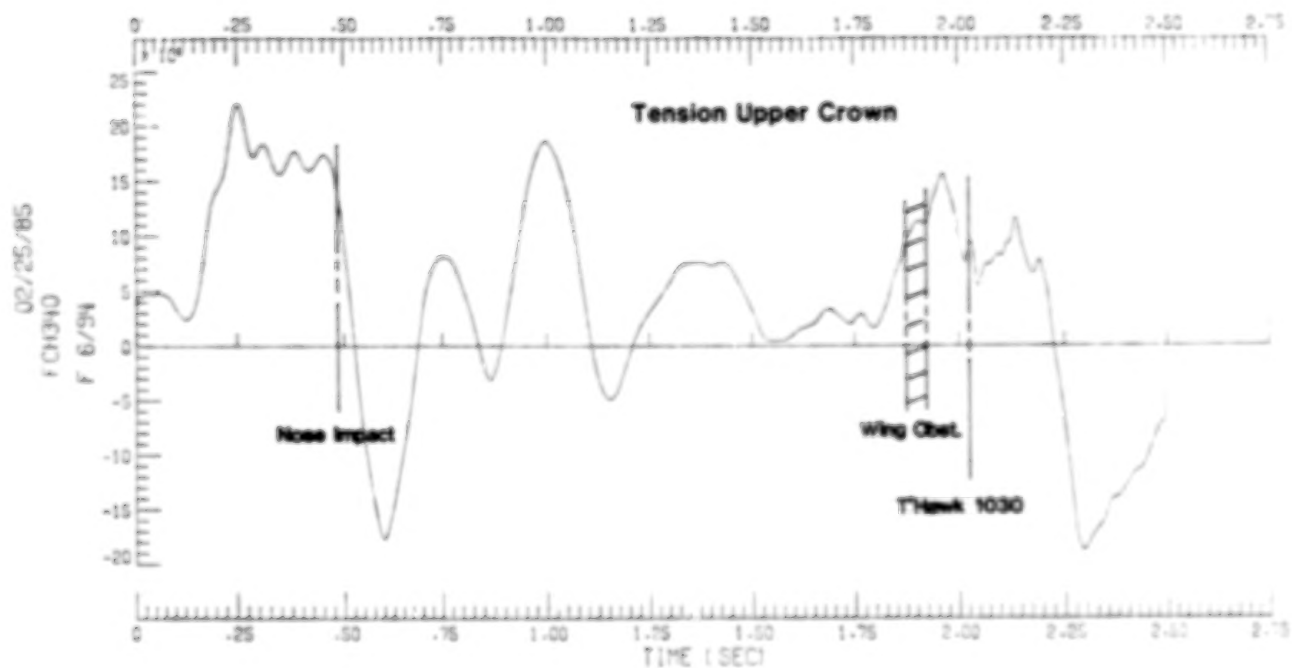
Fuselage B.S. 1130 Vertical Bending

The B.S. 1030 moment bridge again demonstrates consistency of data. The magnitudes of the moments at B.S. 1130 are less than those at B.S. 1030 as expected.

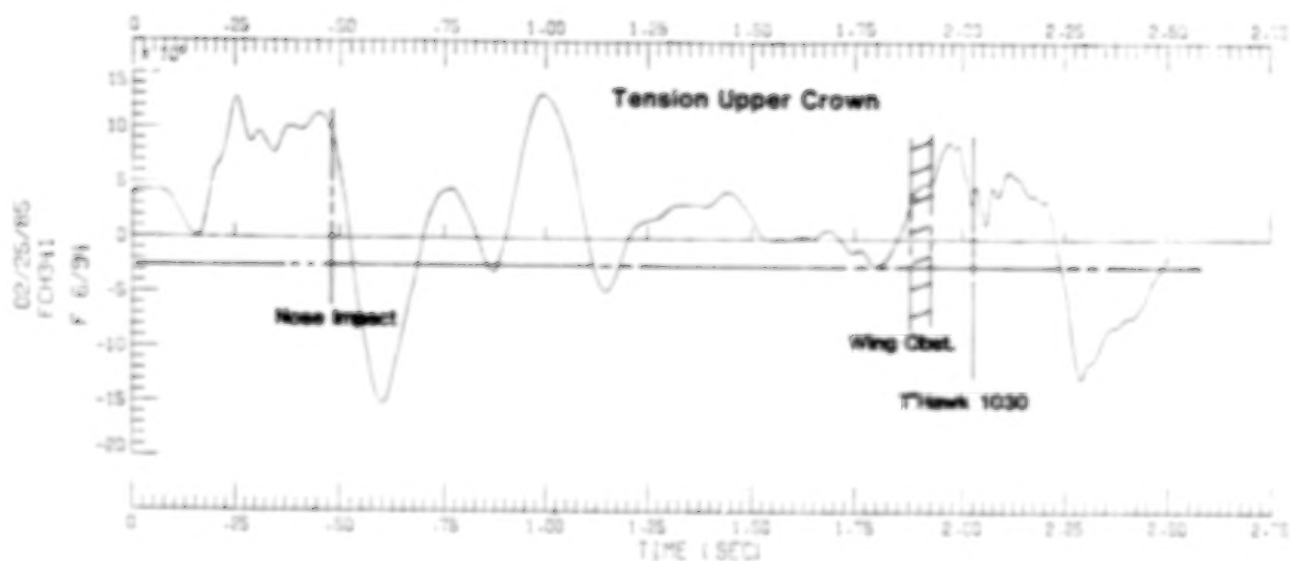
Fuselage B.S. 1250 Vertical Bending

The basic response is again consistent with the other aft fuselage bridges. The magnitudes of the moments does again decrease as one goes aft along the fuselage.

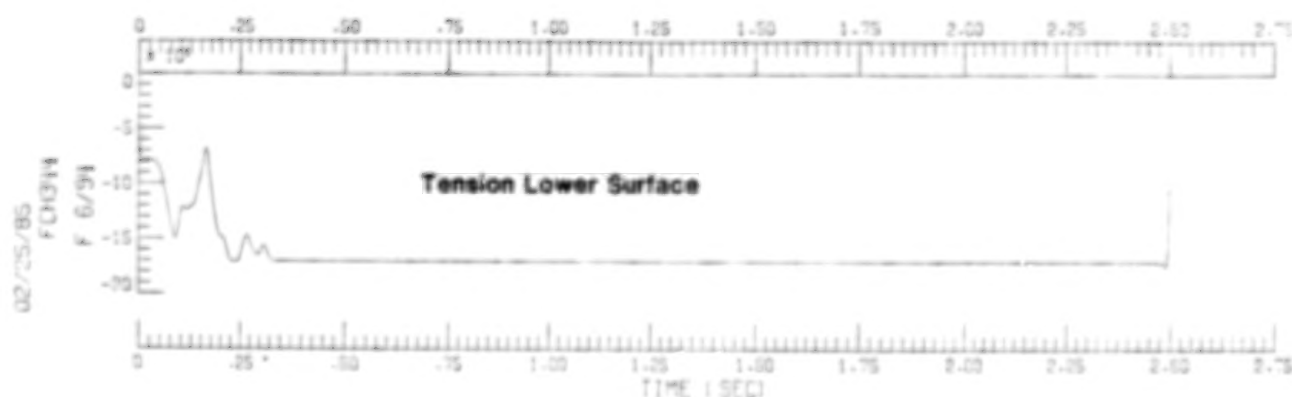
L/H Wing (OutBd) Vertical Bending

The signal from this bridge was lost soon after impact. The strain gages on the lower arm of this bridge were exposed and were not protected from ground impact and were most likely scrubbed off the surface of the wing by the ground impact.

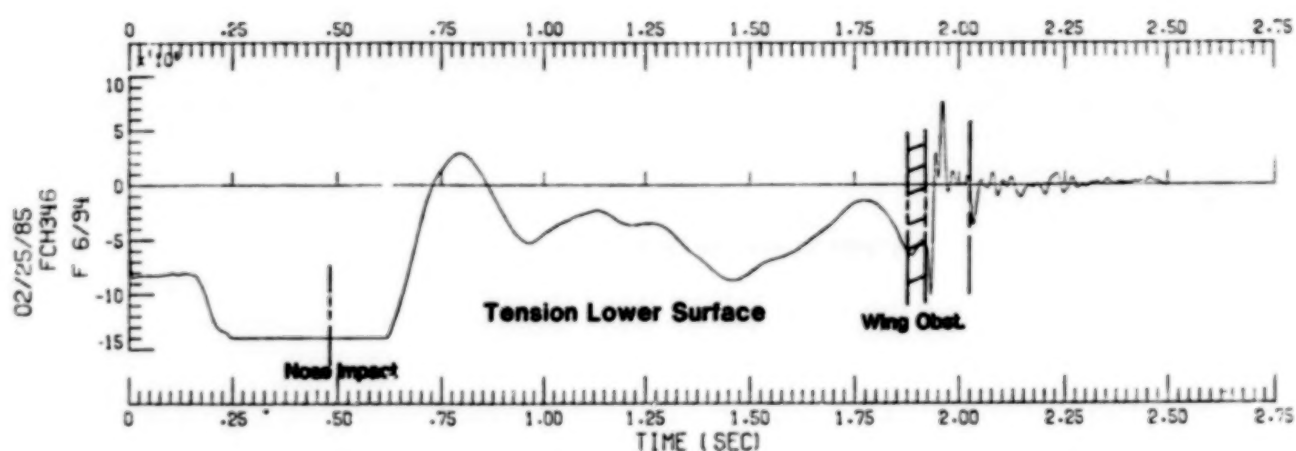
R/H Wing (OutBd) Vertical Bending

This data has yet to be analyzed; however, the encounter with the ground obstacles and subsequent loss of signal are evident. The range of the bridge was exceeded during the nose impact.

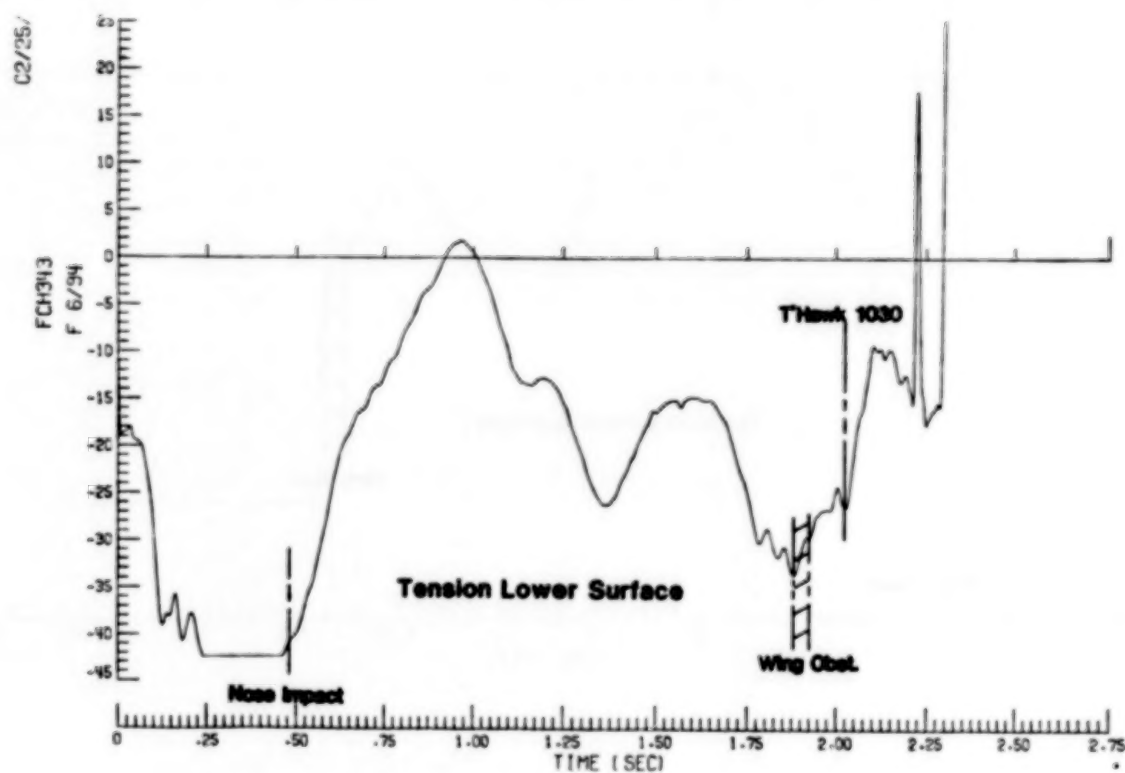
L/H Wing (InBd) Vertical Bending

Data was recorded by the L/H wing inboard bridge. The L/H wing made ground contact. The significant events are again depicted. The range of this bridge was exceeded during nose impact. This bridge lost signal subsequent to impact with the ground obstructions.

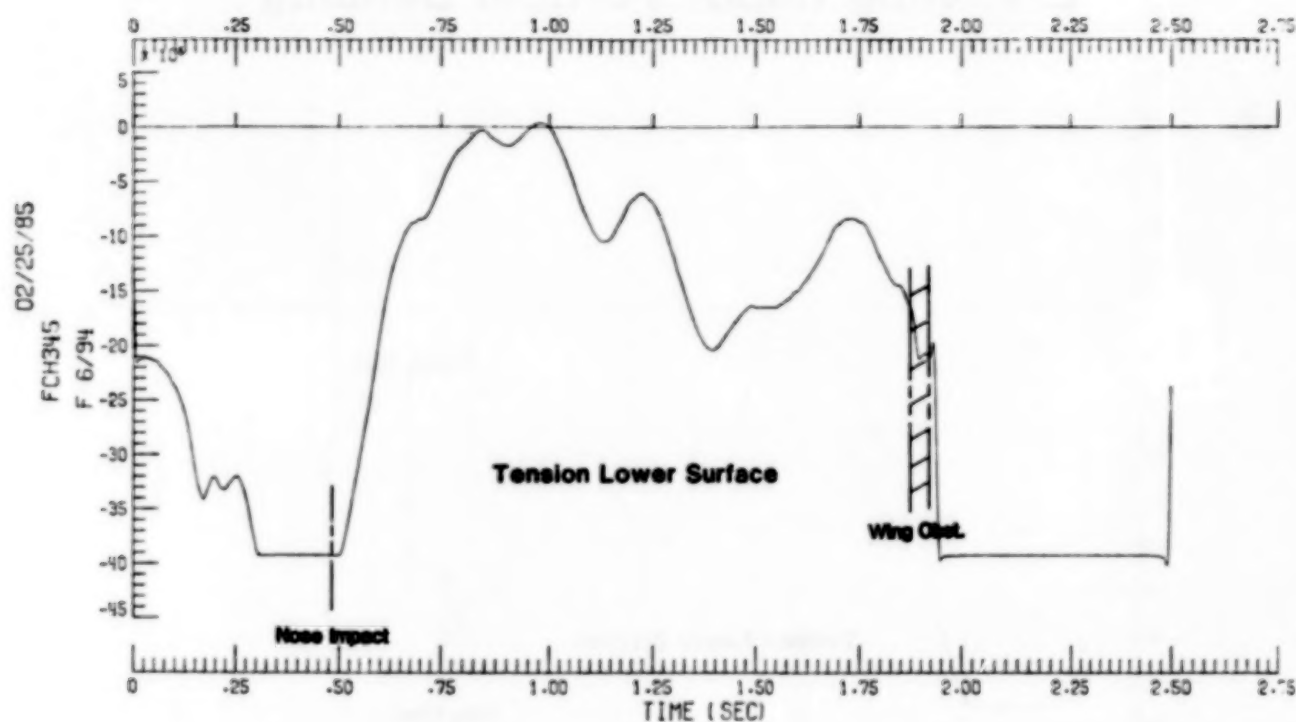
R/H Wing (InBd) Vertical Bending

The R/H wing and L/H inboard bridges surprisingly contain almost identical responses (including magnitudes). That wouldn't be expected since the left wing made ground contact, whereas the right wing never did strike the ground. The nearly identical response between these wing bridges is not widely understood at this time.

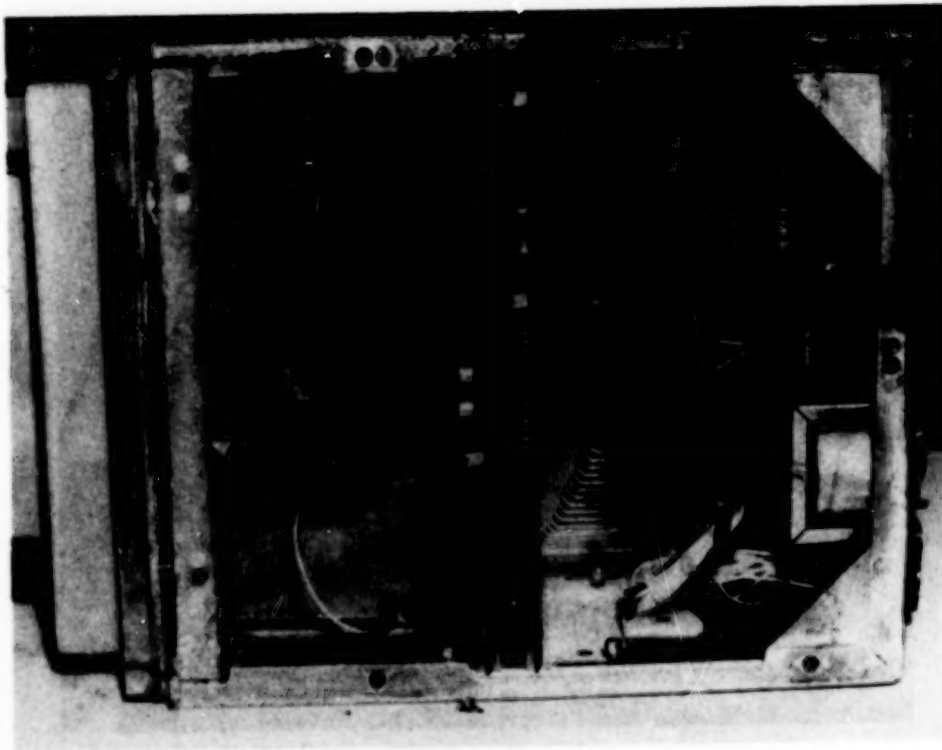
Figure 12 shows the tape deck removed from the unit as well as the drive mechanism. Figure 13, which is a back view, shows some scorching inside in the tape drive section, but again, this was of no concern to us. Figure 14 shows a closeup of the tape drive system recording heads and the interconnect module.

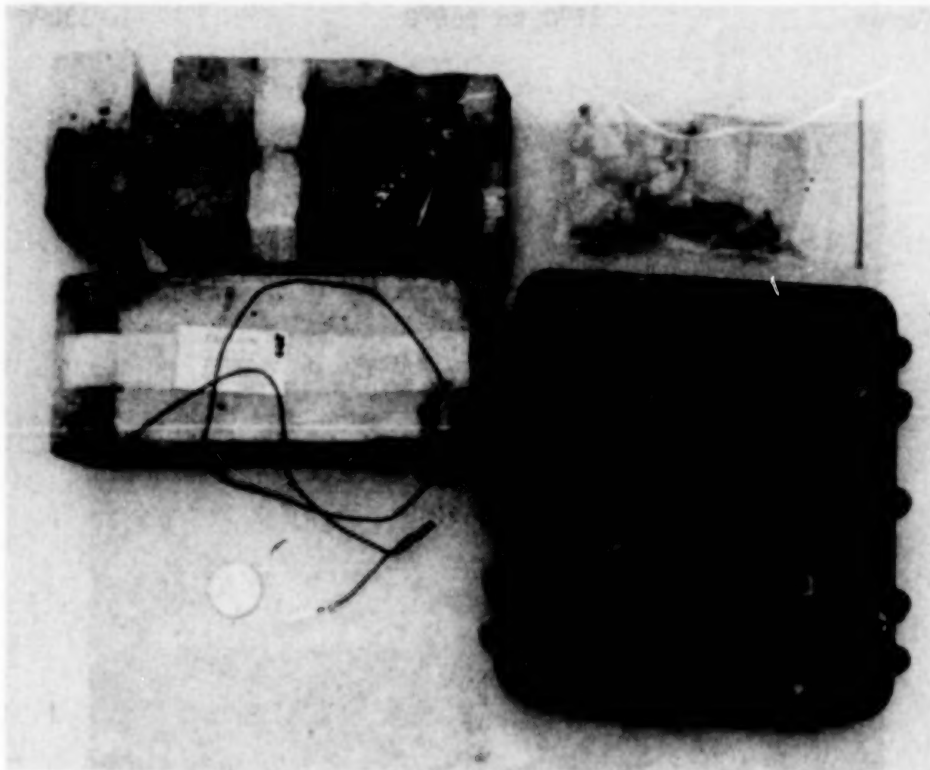
Figure 13
RBA-46 PAYLOAD COMPONENTS REMOVED FROM CAVITY

The crash fluids consisted of AMK jet fuel and fire fighting foam. The fire fighting foam is electrically conductive, very corrosive and has a very low surface tension. Low surface tension allows it to flow rapidly into cracks, etc. This fluid extensively damaged various components of the airfoil payload as shown in figure 13.

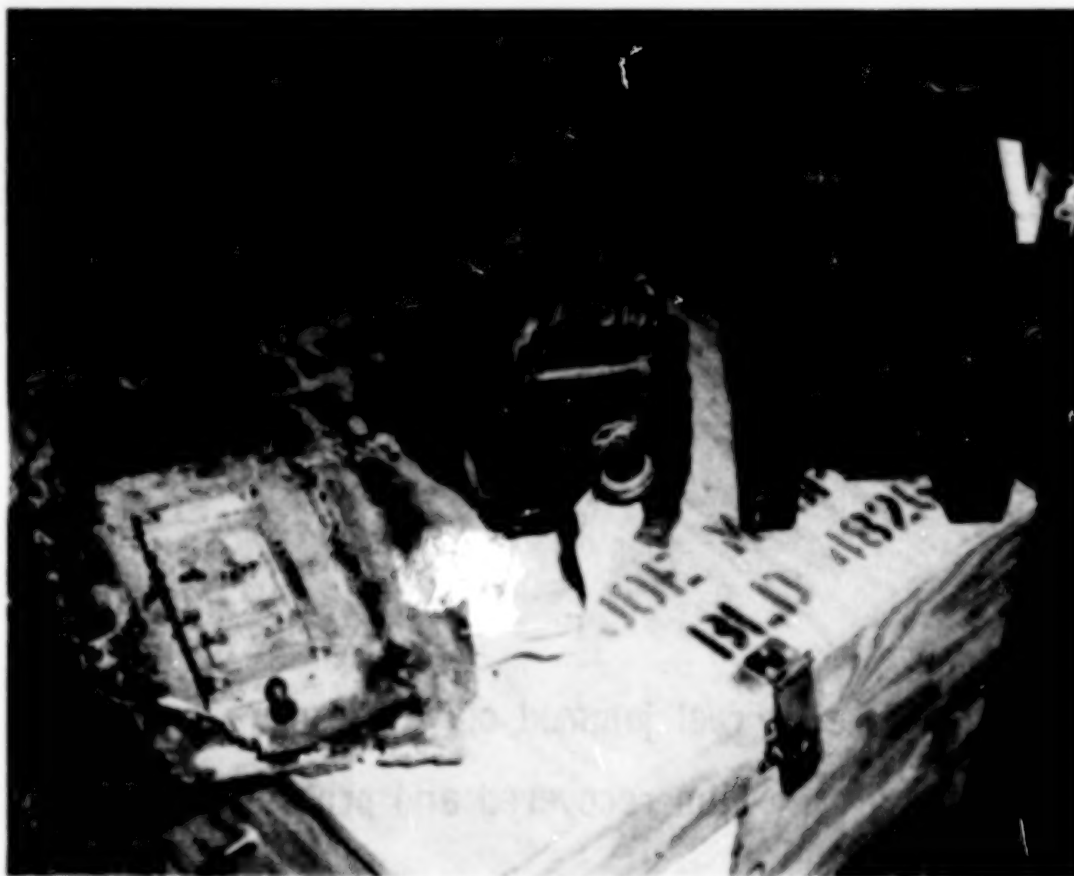
Figure 19

The post crash condition (front view) of a typical camera, heatshield and mounting bracket is shown in Figure 19. The heat resistant material under the camera and the heatshield provided excellent protection for the camera despite the fact that the aluminum mounting bracket practically melted away. The smoke deposits on the camera housing was cleaned off revealing the original paint hardly scorched.

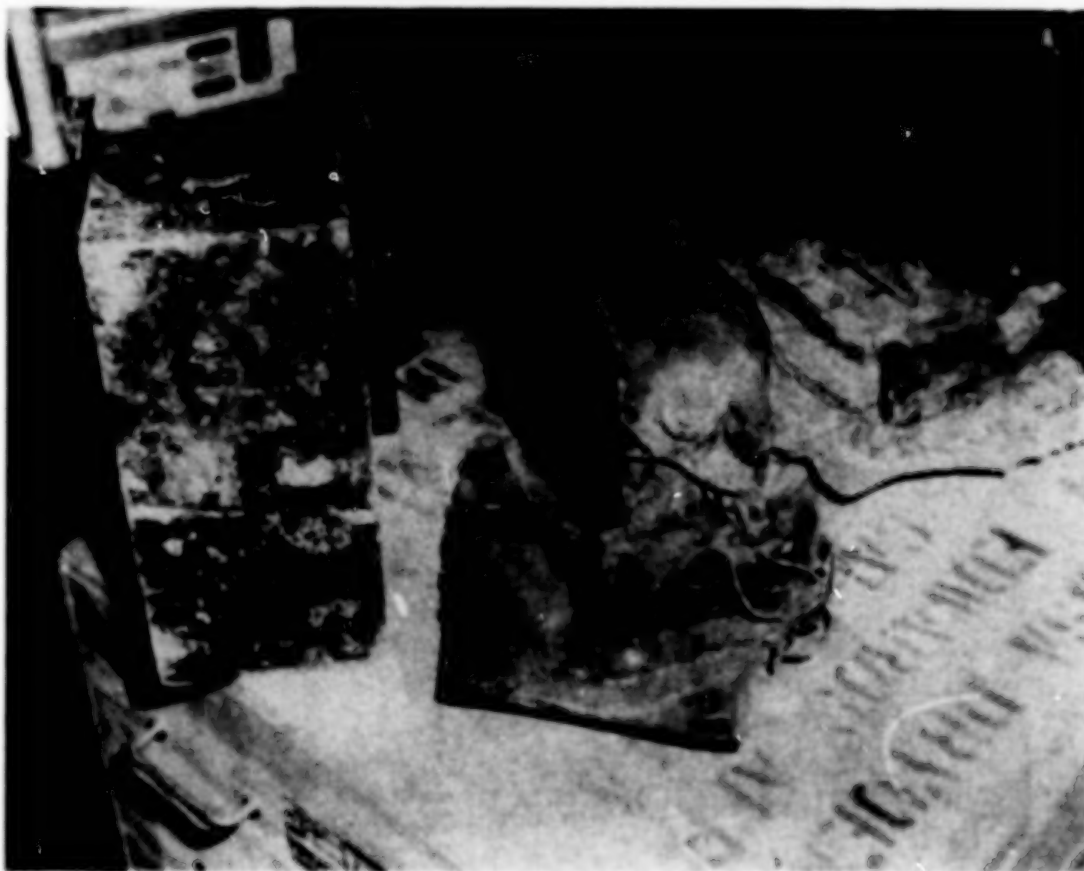
Figure 20 is the rear view of the same camera and other hardware shown in Figure 19.

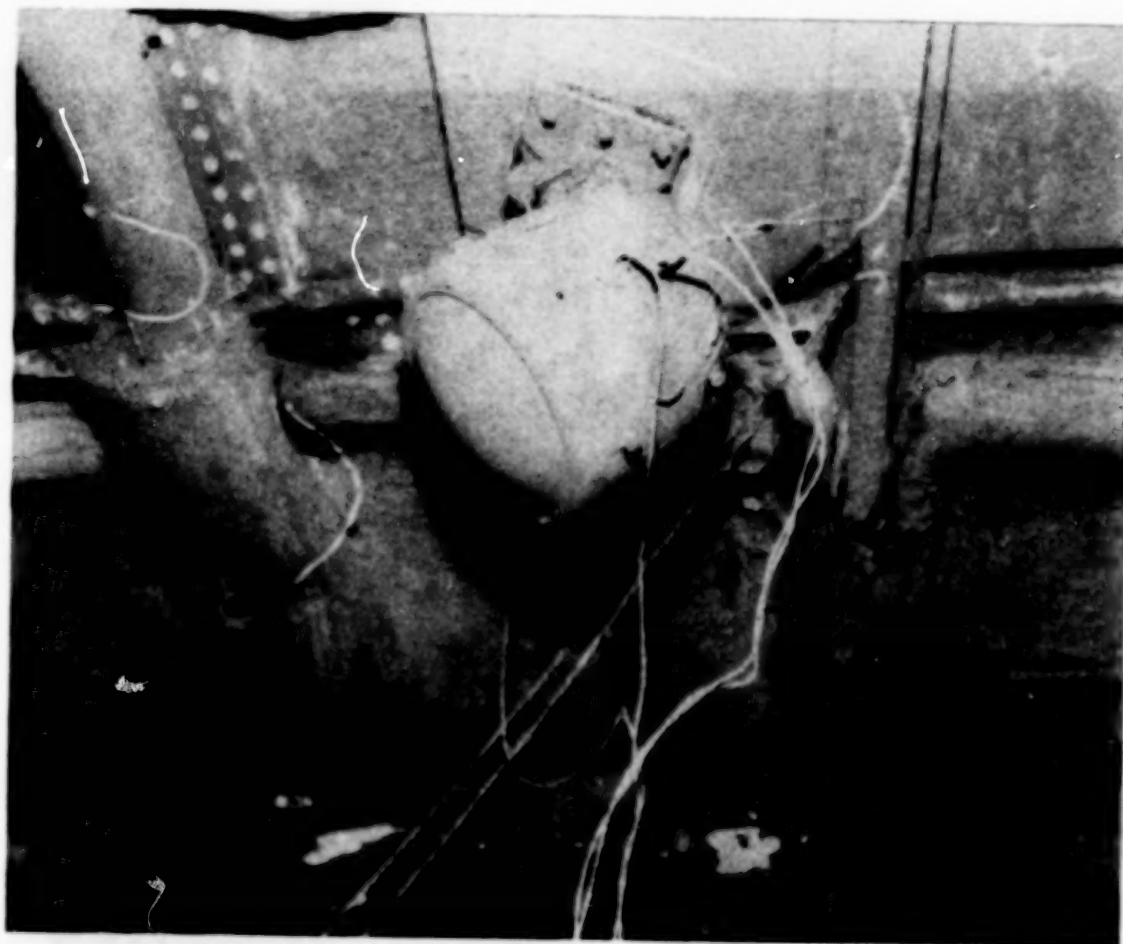
Figure 26

This photograph of one light fixture (Fig. 26) was taken shortly after the crash. It is obvious that the assembly, as did all 24, survived the crash with no physical damage. However, the extreme heat did melt the wires and polyurethane material.
